EB Shower Seat Load Tests

Objective: Determine the safe working loads of the EB range of shower seats. Test results generated assumed across all EB model seats given identical componentry and adoption of 'worst case' in terms of seat size (width).

Item: EB1-700 Seat.

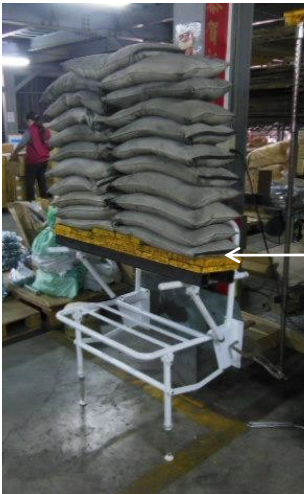
Illustration A
300kgs load applied to (spread over) both aluminium arms. No deformation evident.

1. EB1-700 assembled on a test rig, simulating a secure 'real life' installation against a wall.
2. Load 300kg on the aluminium armrest to test the armrest loading capacity (see illustration A).
3. After 20 minutes, remove the load and check the armrest status.

Result: PASS - arms and seat move freely and operate correctly with no visible signs of damage, deformation or defects following or during the application of the loads.

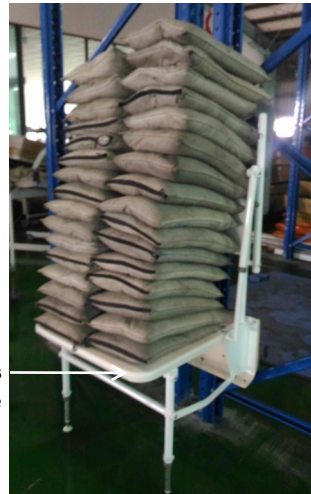
Illustration B
350kgs applied to the seat base.

1. EB1-700 assembled on a test rig, simulating a secure 'real life' installation against a wall.
2. Load 350kgs on to the seat base, with pad removed for load stability (see illustration B).
3. After 20 minutes, remove the load and checked the seat status.
